Preliminary Geospatial and In Situ Reconnaissance of the 8 September 2023 Moroccan Atlas Earthquake Damage

Citation: González-Rodrigo, B.; Navas-Sánchez, L.; Rejas-Ayuga, J.G.; Hernández-Rubio, O.; Benito, M.B. Preliminary Geospatial and In Situ Reconnaissance of the 8 September 2023 Moroccan Atlas Earthquake Damage. *Buildings* **2024**, *14*, 693. <https://doi.org/10.3390/buildings14030693>

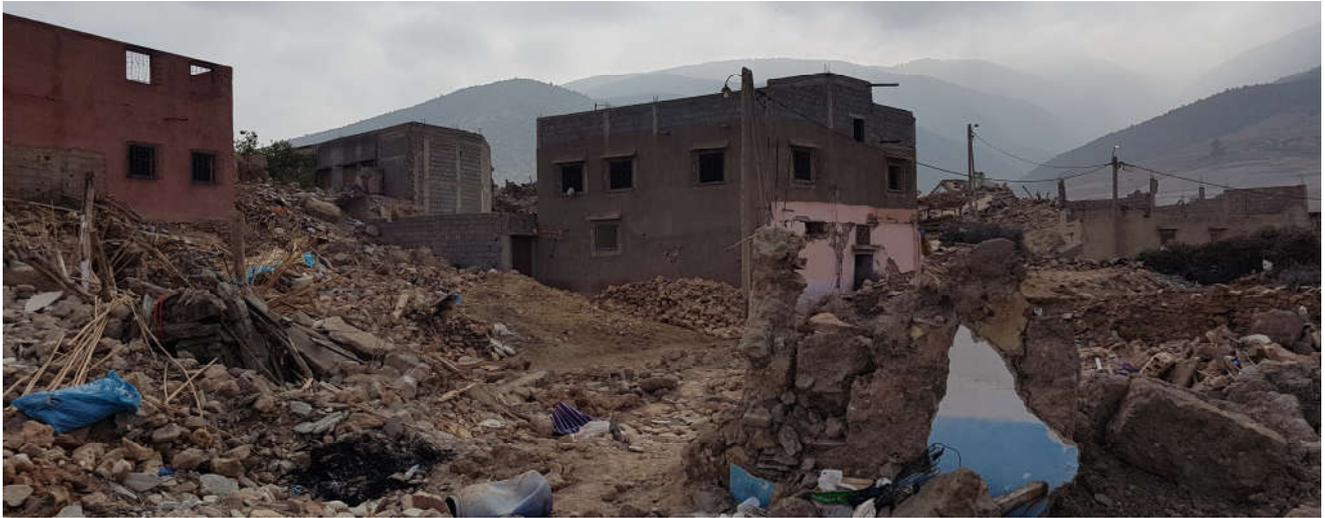
In accordance with the EMS manual [31], the structures in Tafeghaghte, primarily composed of stone masonry with non-anchored one-way wooden floorings, are categorized as Class A vulnerability. Most of these buildings had collapsed (grade 5), whereas confined masonry constructions suffered less damage (grade 2 to 4), suggesting an intensity of approximately IX in this area (Figure 7). In contrast, in the analyzed area of Talat N'Yaaqoub there were numerous constructions with confined masonry walls made of concrete blocks with beam and block floorings, classified as Class C vulnerability [31]. A less-vulnerable construction system recommended by Moroccan seismic regulations and other guidelines in regions with high seismic-threat [13,32] suffered damage ranging from

Figure 7. Evaluation of damage along a street in Tafeghaghte subsequent to the 8 September 2023 earthquake. Stone masonry structures have predominantly collapsed, while confined masonry systems or confined mixed systems mostly display damage ranging from grade 2 to 4 [31].

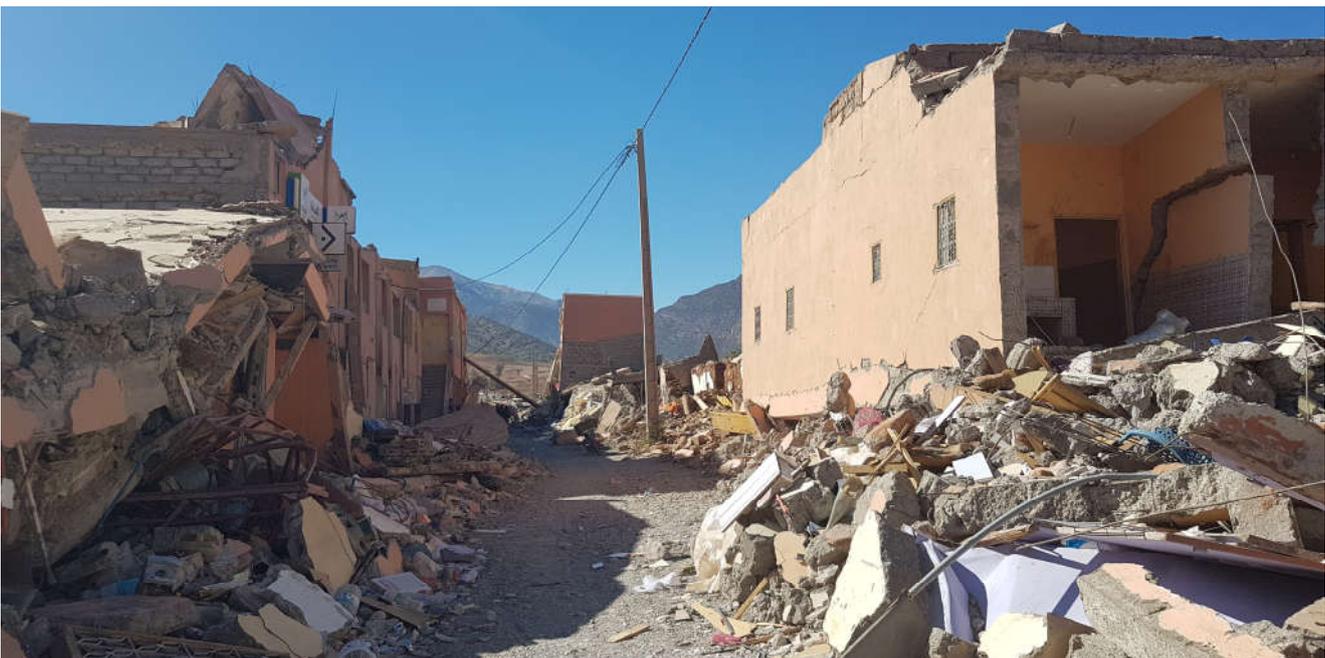
Figure 8. Assessment of damage in a street of Talat N'Yaaqoub following the 8 September 2023 earthquake. Confined masonry structures exhibit extensive destruction, with buildings suffering grade 3 or higher damage, and numerous collapses recorded at grade 5 [31].

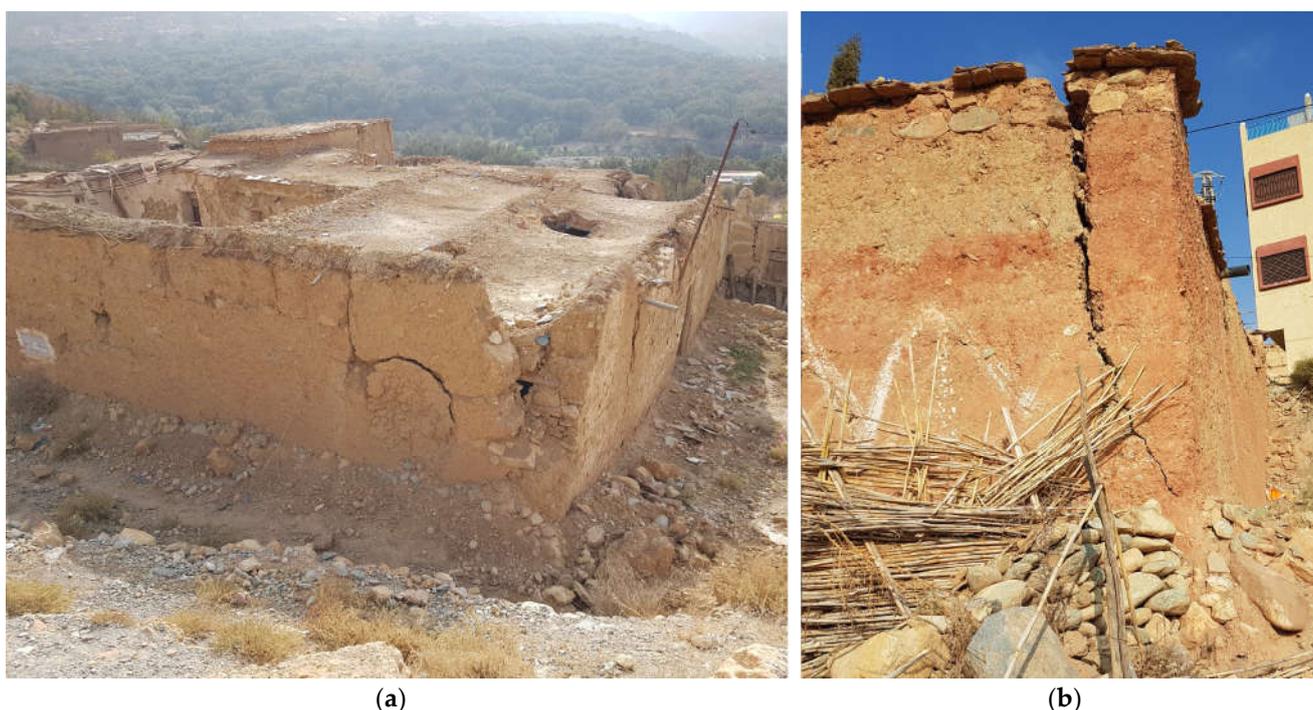
Single and two- or three-story residential houses comprise load-bearing earth walls ranging in thickness from 50 to 60 cm. Over time, the material tends to lose cohesion. The floor slabs are typically heavy, consisting of wooden beams covered with straw and compacted earth. There is often a lack of diaphragms, inadequate support, and an absence of anchoring of floor and roof elements to walls, leading to highly flexible floor systems and deficient roof structures (Figure 10). Moreover, due to the lack of cohesion, characteristic of this material, perpendicular walls present a lack of box behavior. The vulnerability of this type of construction is not included within the classification provided by the EMS-98; however, its main features make these buildings more vulnerable than those considered the most vulnerable in this scale, those in Class A. Therefore, it would be reasonable to consider them as not classified (equal or inferior to class A).

Figure 10. Out-of-plane failure of an exterior wall on a rammed-earth building with a floor constructed from wood, straw, and mud. These images highlight insufficient connectivity observed between the perpendicular walls and the floor diaphragms. Image (a) displays damage to the corner and a portion of the parapet and image (b) illustrates an out-of-plane failure of a wall. The buildings were situated in the central area of Adassil.

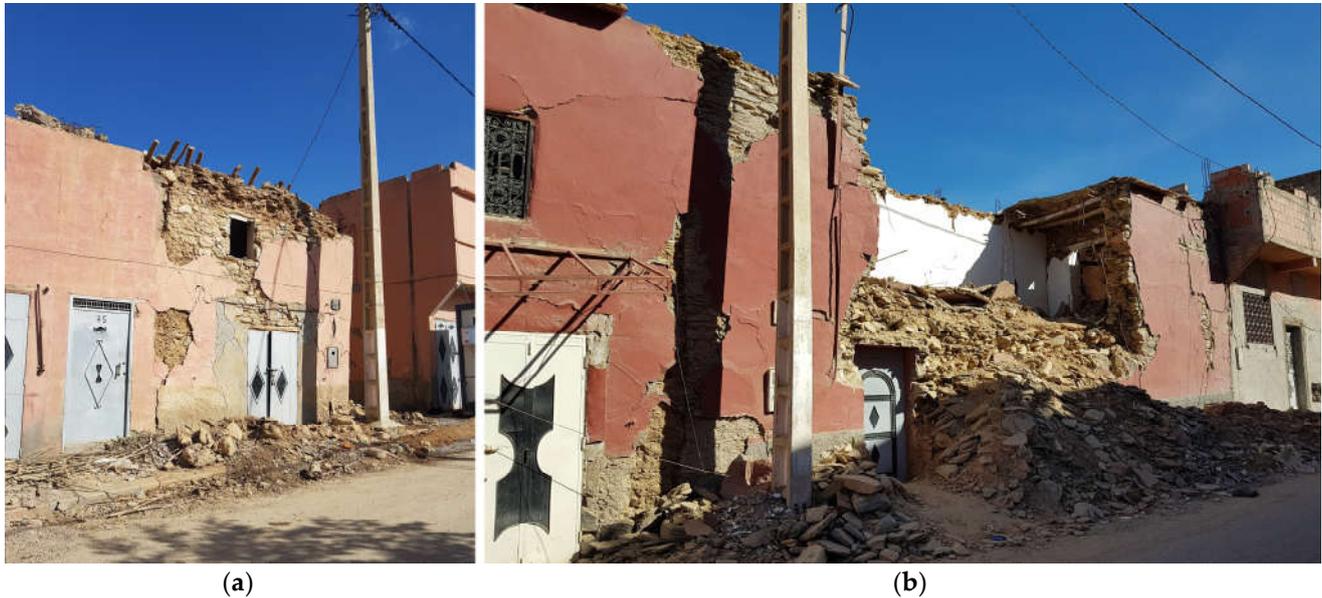
Figure 11. Impact of the 8 September 2023 earthquake on a stone masonry building with wooden log slab in Amizmiz. Image (a) illustrates the inward collapse of the roof, attributed to inadequate support, leading to the subsequent collapse of the upper part of the wall. Image (b) shows the crumbling of the walls.

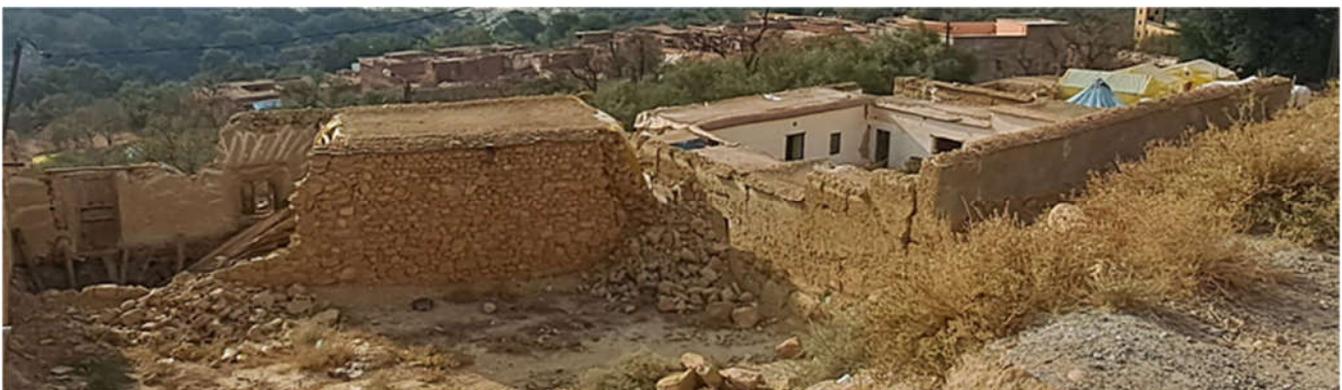
The most prevalent failure mode identified in traditional structures was the partial or complete overturning of walls out-of-plane, as depicted in Figure 12. This failure pattern is commonly associated with inadequate connections between perpendicular walls or floors [35,36]. In stone masonry, such failure is frequently witnessed in instances of wall collapse caused by weak mud mortar, inadequately integrated multi-leaf stone wall construction, and insufficiently supported floors [37].

Figure 12. Impact of the 8 September 2023 earthquake on a traditional building in Adassil with a floor made of wood, straw, and mud. The observed damage includes the disintegration of sections

of the stone masonry walls of the house and failure characterized by perpendicular bending at the corners of the rammed-earth dwelling.

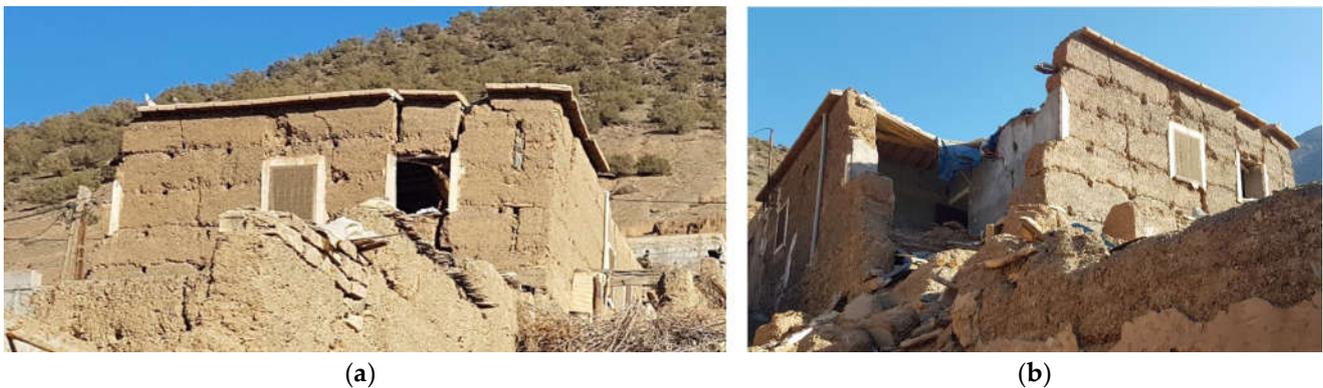
In the context of isolated or corner buildings, particularly those constructed with rammed earth, corner failure was also observed. This type of failure was more prone to occur in scenarios where nearby openings (Figure 13) or structural designs contributed to an accumulation of stress at the corners. In the case of construction systems using earth, observed specifically in the study of Adassil, the rammed-earth buildings with a quadrangular shape and a central patio exacerbated the concentration of stress at re-entrant corners, as illustrated in Figures 10 and 12. This behavior was also observed in stone masonry, where the concentration of stress in tension and the irregular shape of the building was the cause of the observed damage (Figure 14).

Figure 13. Damage assessment of a traditional rammed-earth building depicting various stages of damage. The corner failure is exacerbated by the presence of window openings. (a) Partial corner failure, (b) Total corner failure.

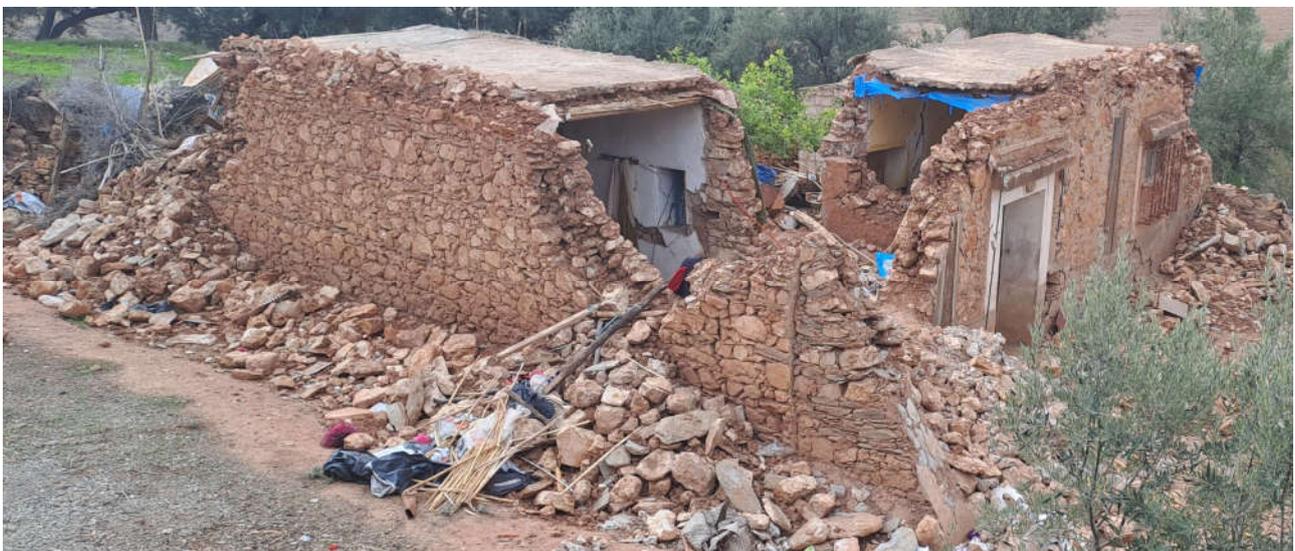
Figure 14. Damage observed in an L-shaped masonry residential structure. The damage at the corner is evident, attributed to concentration of stress in this specific area. Residential dwelling in the vicinity of Tafeghaghate.

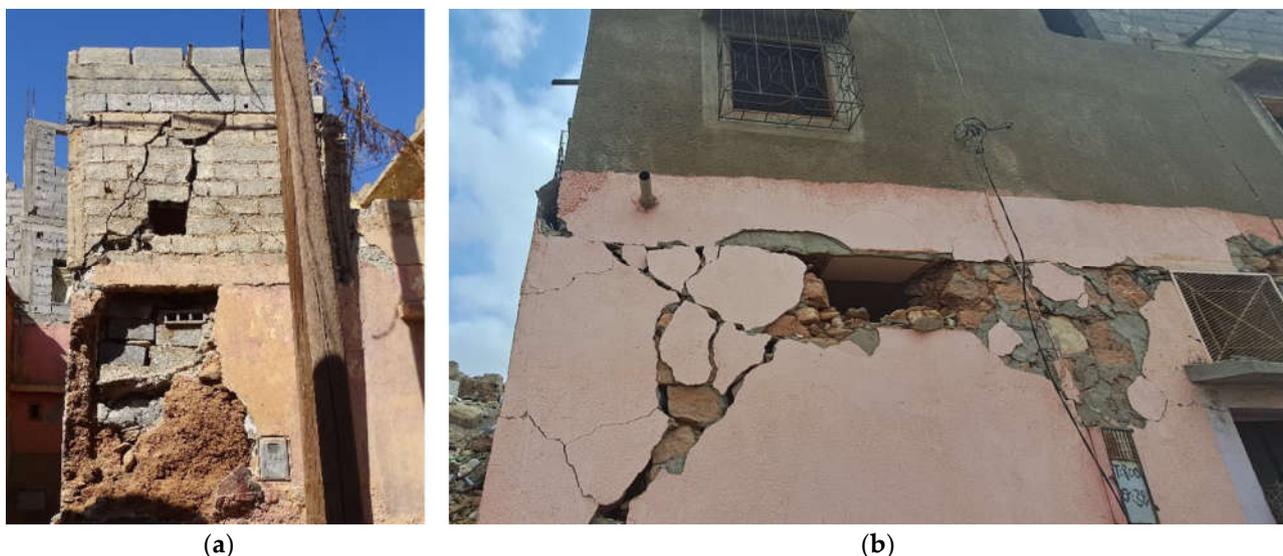
construction elements was decisive in the seismic response of the buildings. Furthermore, the difficulty involved in adequately connecting the two construction systems underlies the fact that many buildings presented damage resulting from sliding between lower walls and upper floors of differing materials (Figure 15b). Additionally, the positioning of these dwellings within the aggregate might influence their seismic response [38–40].

Figure 15. Traditional ground-floor buildings with upper floors constructed using reinforced masonry. Image (a) shows evident inadequate connections between traditional and modern construction elements. Image (b) illustrates the lack of connection, combined with varying stiffness among the floors, resulting in the manifestation of horizontal cracks. Location: Amizmiz and Tafeghaghat.

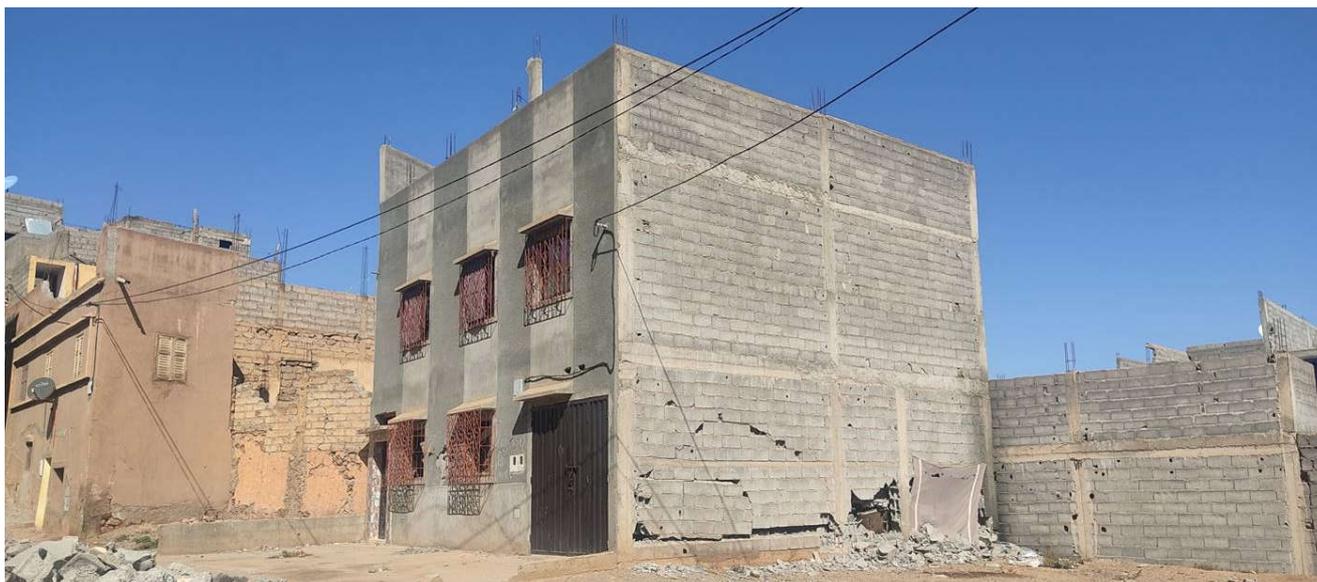
According to the observations, most of these confined masonry and RC constructions have certain characteristics in common. Generally, they have up to four stories, except for those of special interest to the population such as mosques. These stories may be constructed at the same time or in successive phases, using masonry infill materials with similar or different characteristics. In this regard, it is common to find starter bars at the top of columns to facilitate the anchorage of RC elements of future upper stories (see Figure 16).

Figure 16. Several buildings with starter bars at the top of columns to facilitate the anchorage of RC elements of future upper stories (Amizmiz).

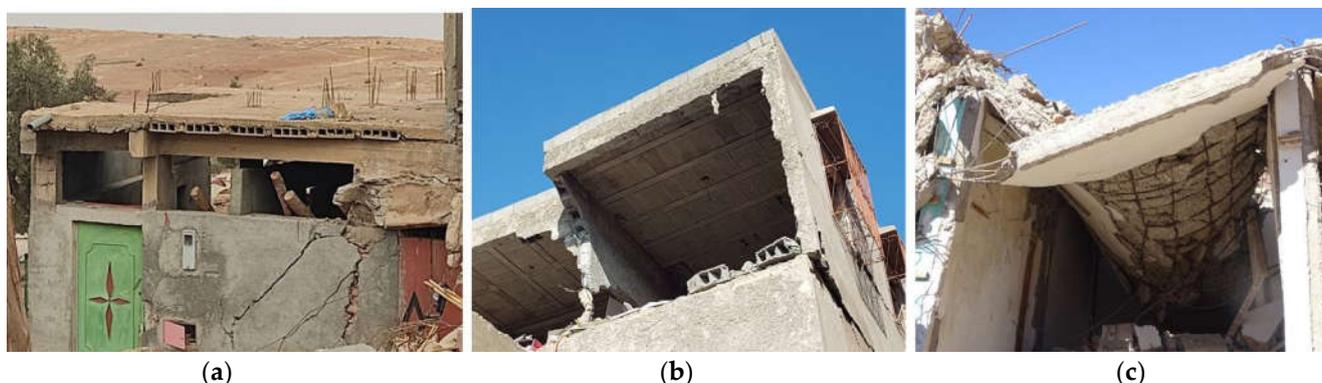
Furthermore, with regard to structure, the horizontal elements were mainly composed of RC joists and concrete hollow blocks with a reinforced or unreinforced compression deck layer (Figure 17a,b). In these cases, a diaphragmatic effect of floor systems is unlikely, due to the low quality of the components and the weak connection between horizontal and vertical elements. Nonetheless, exceptionally, a few cases were identified of reinforced concrete slabs with extremely high ductility in comparison with the vertical structures (Figure 17c).

Figure 17. Several buildings with starter bars at the top of columns to facilitate the anchorage of RC elements of future upper stories. (a) Tafeghaghte, (b) Amizmiz, (c) Talat N'Yaquod.

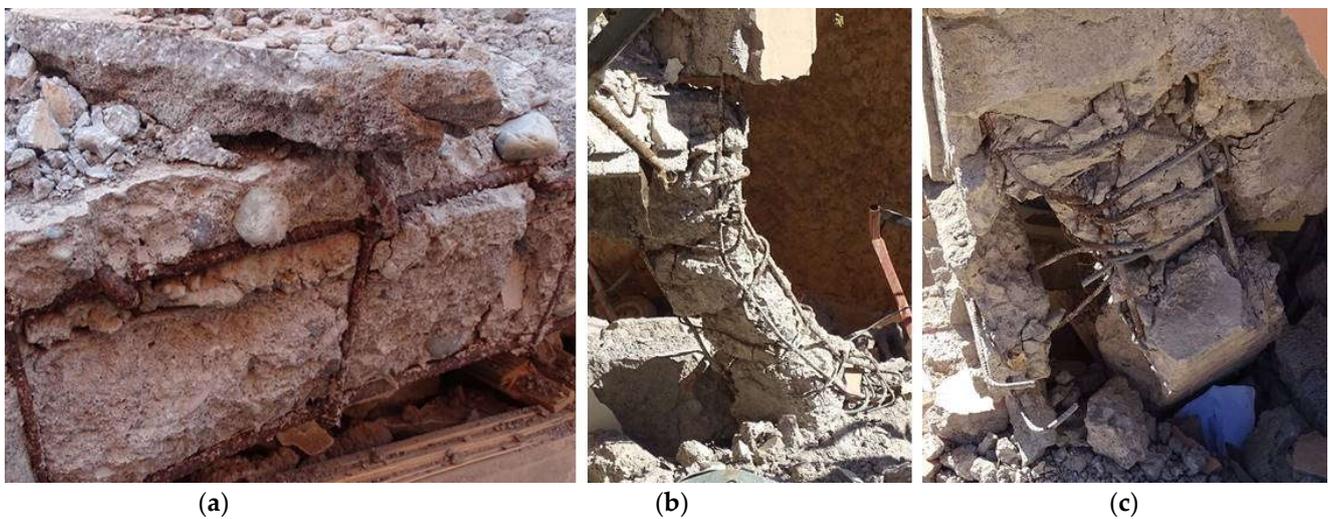
The compression strength of the concrete is one of the most important parameters for seismic behavior in both reinforced-concrete and confined masonry typologies. For this reason, some of the current building codes (EC8 and ACI-318) stipulate a minimum threshold of 20 MPa. In this regard, the RPS 2000 version 2011 establishes a minimum concrete compression strength of 22 MPa. Despite this legal requirement, the visual inspection of constructions revealed that the concrete quality was deficient in several aspects: visible porosity and cavities, discontinuous granulometry and the employment of large rounded aggregates (Figure 18). This low resistance and lack of cohesion of the material was also evidenced by its fragile rupture when exerting manual pressure. Furthermore, in some cases, the steel reinforcing bars were flat, unribbed, or with minimal ribs, which also contributed to poor overall behavior due to the extremely low adherence (see Figure 19). Only in a very small number of cases was corrosion of the steel reinforcement bars detected.

Figure 18. Low-quality reinforced concrete due to visible porosity and cavity/holes, discontinuous granulometry, and the employment of large rounded aggregates in structural elements pertaining to different buildings (Talat N'Yaquod) (a–c).

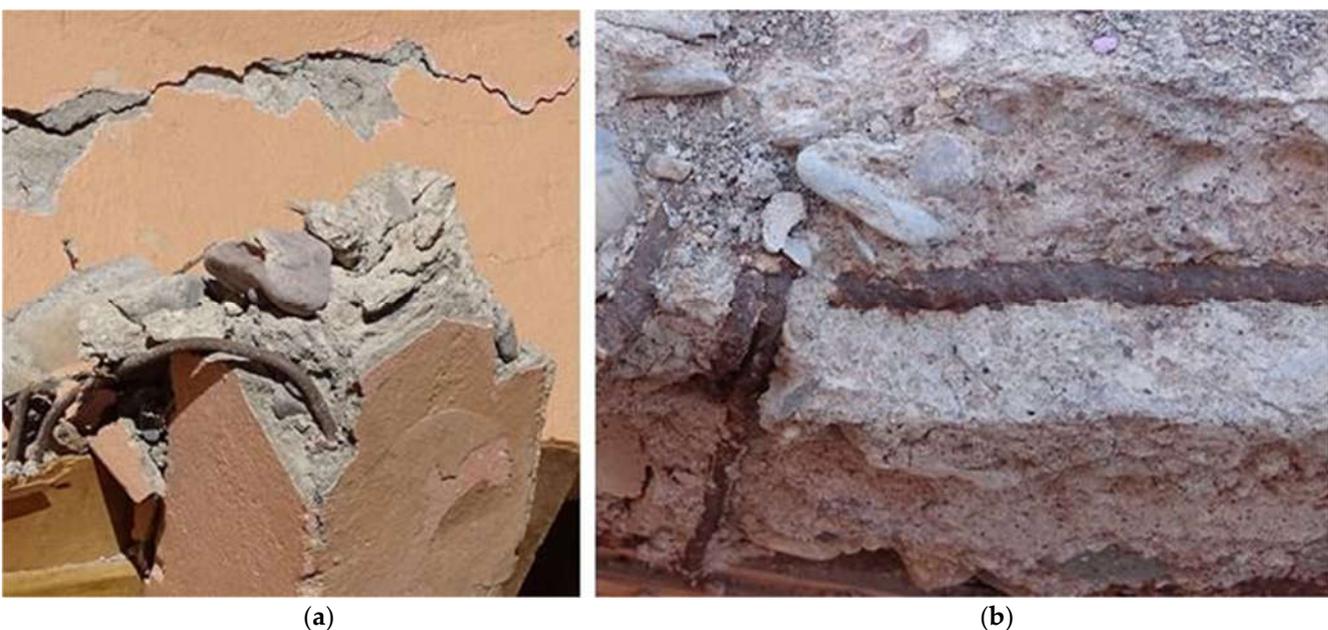
Figure 19. Deficiencies in steel bar reinforcement in concrete elements: (a) smooth bars; (b) presence of corrosion and minimal transversal ribs in longitudinal reinforcement (Talat N'Yaquod).

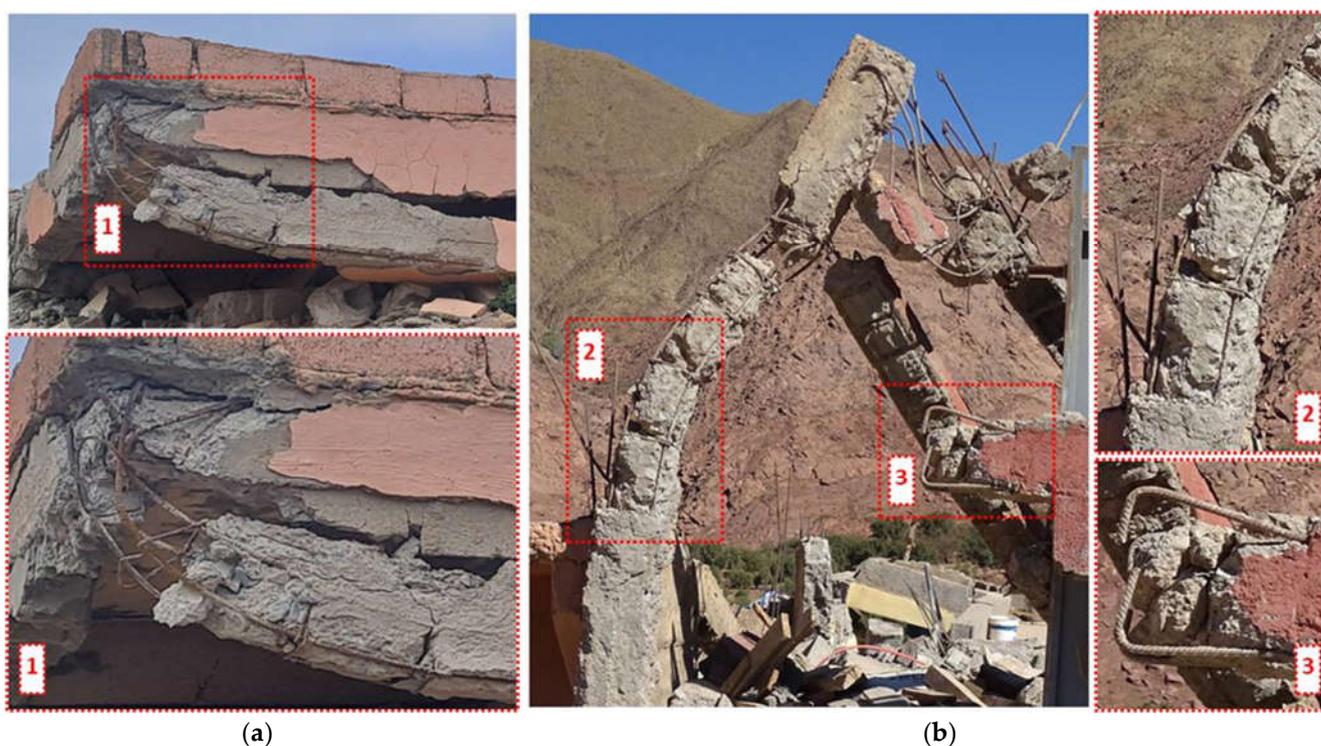
Furthermore, the dimensions of the transversal sections of the columns and the steel stirrups were identified as being insufficient for both confined-masonry and RC frame constructions, given the damage observed, such as fragile failure (Figure 20). Additionally, the abovementioned dimensions were below those established in the RPS 2000 version 2011, which in turn are below those established in the EC8 and ACI-318 codes. Specifically, the steel stirrups were not only insufficient in number and sometimes inexistent, but also excessively distanced (Figure 20, details 1 and 2), in several cases exceeding 25 cm. In addition, widespread use of stirrups with hooks at 90° at their ends and reduced development length was detected, resulting in these elements opening more easily under the earthquake load. In this regard, reference regulations for RC with special requirements for seismic zones, such as ACI 318 [42], state that the hooks should have an angle of 135° and that the minimum length should be six times the diameter of the bar and longer than 75 mm (Figure 20, detail 1). Similarly, it was observed that overlapping of the longitudinal steel bar reinforcements was frequently carried out in areas of greatest demand, for example, near the beam–column joints. Moreover, it was found that the development length of the longitudinal steel reinforcement was insufficient at the junction of beams with end columns (Figure 20, detail 3).

Figure 20. Deficiencies in RC elements that lead to low-ductility sections and fragile failure. Details 1 and 2: fragile failure in the support at the floor-support-system joint due to low-quality concrete, excessive distance between steel stirrups at a critical point, and non-earthquake-proof hooks ($<135^\circ$ or length less than 6ϕ or 75 mm) in the joint. Detail 3: short development length and deficient anchoring of steel for longitudinal reinforcement of the beam where it connects with the column. (a) Amizmiz; (b) Talat N'Yaquod.

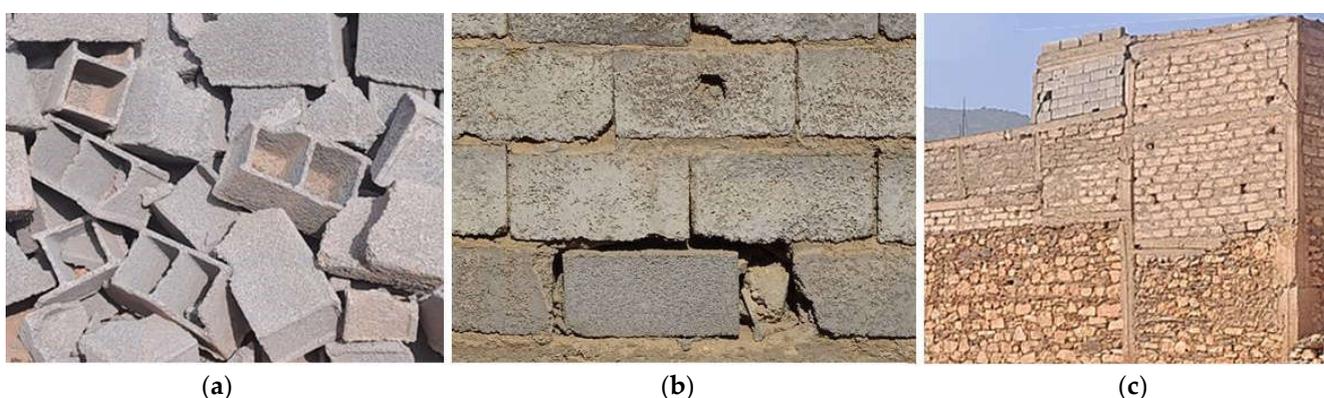
pieces with low resistance to compression, easily identifiable in a visual inspection. As shown in Figure 21a, the components present very low cell thickness, around 1 cm, which considerably decreases their transversal section. Moreover, the cement–mortar joints between pieces are sometimes much thicker on their horizontal faces (Figure 21b), non-uniform, and highly variable in thickness. These factors, in part, account for the generalized poor performance of masonry buildings, which presented extreme damage and numerous complete collapses. Similarly, some of the mixed structures observed combined cement–mortar hollow-block masonry walls of very dissimilar characteristics or these elements combined with solid blocks of mortar or hollow pieces of fired clay or natural stone, or, in some cases, even a combination of various of these materials (Figure 21c). The effect of the combination of different confined materials on the structural behavior of the buildings has proven to be highly significant. Figure 22 shows the highly dissimilar results for the different materials combined in the same construction: the parts of the wall constructed of concrete blocks withstood the earthquake, whereas the stone parts collapsed.

Figure 21. (a) Cement–mortar blocks (Tafeghaghte). (b) Bed joints (Amizmiz). (c) Different types of masonry of highly dissimilar quality in the same wall (Tafeghaghte).

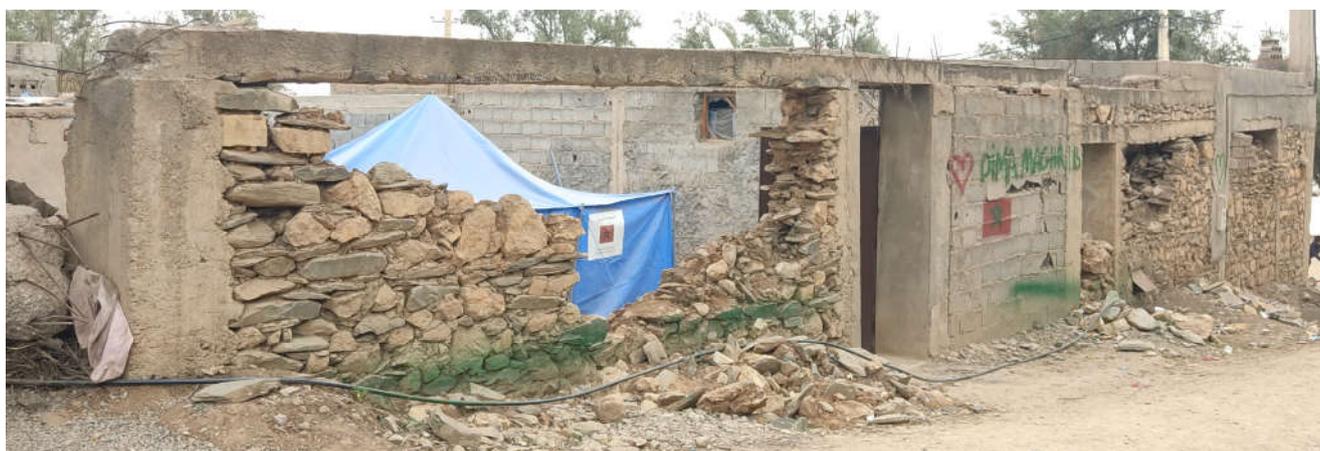
Figure 22. Comparison of damage for different infill materials in the same wall (Tafeghaghte).

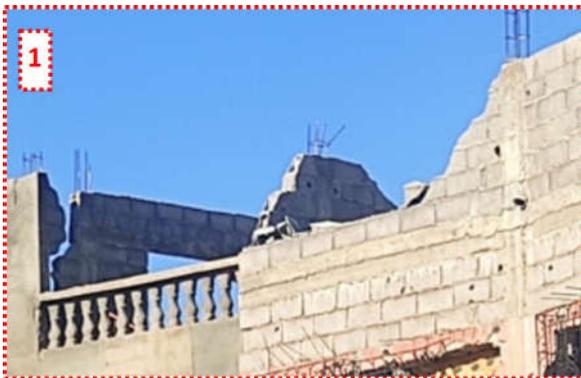
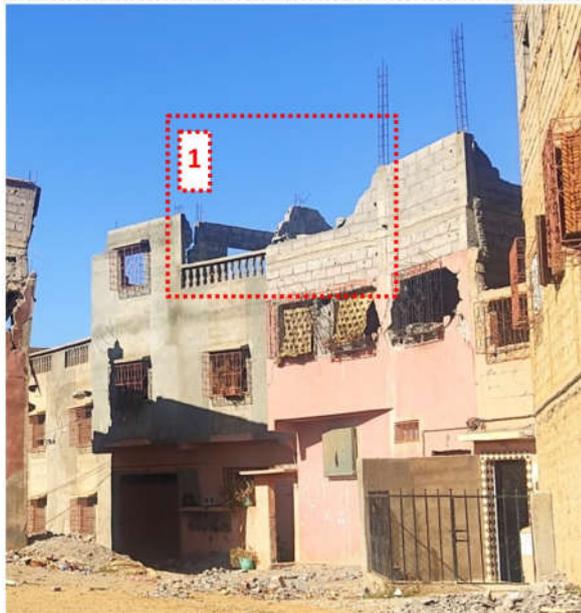
confining beams and columns which were poorly bounded to extremely low-shear-strength hollow concrete blocks, which failed during the seismic event (Figure 23a).

Figure 23. Out-of-plane failures: (a) a confined masonry load-bearing wall and parapet wall because of the low-quality materials employed (Amizmiz). (b) Failure of a masonry wall with RC beams and columns due to the low shear strength of the masonry employed (Amizmiz). (c) Out-of-plane failure of a masonry wall with RC beams and columns due to inappropriate order of execution of components (Amizmiz). The structure does not behave as a confined masonry structure.

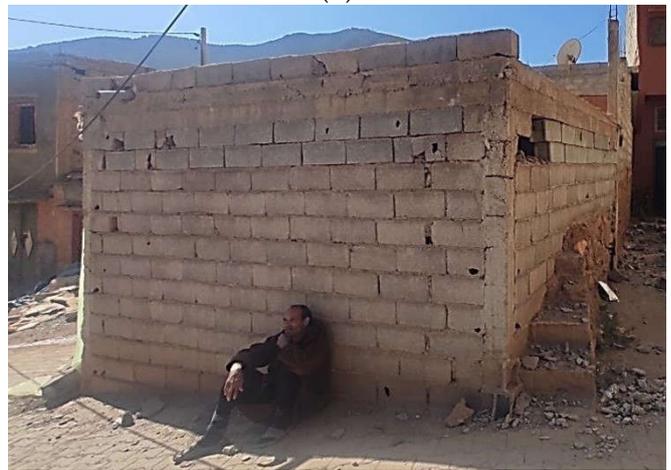
(c)

Similarly, low-quality connections between vertical elements and low-quality materials were identified as factors causing out-of-plane failure of walls (Figure 23). Mention should be given to cases of some buildings combining RC frames and masonry walls presenting out-of-plane failure of infill walls. This occurred either due to inefficient connection (Figure 23c) or inadequate sequencing during the execution of the different components: reinforced concrete beams and columns were erected before the block walls, leading to poorer structural behavior than would be the case in a confined masonry structure with the same quantity of materials (Figure 23c). Moreover, some buildings presented

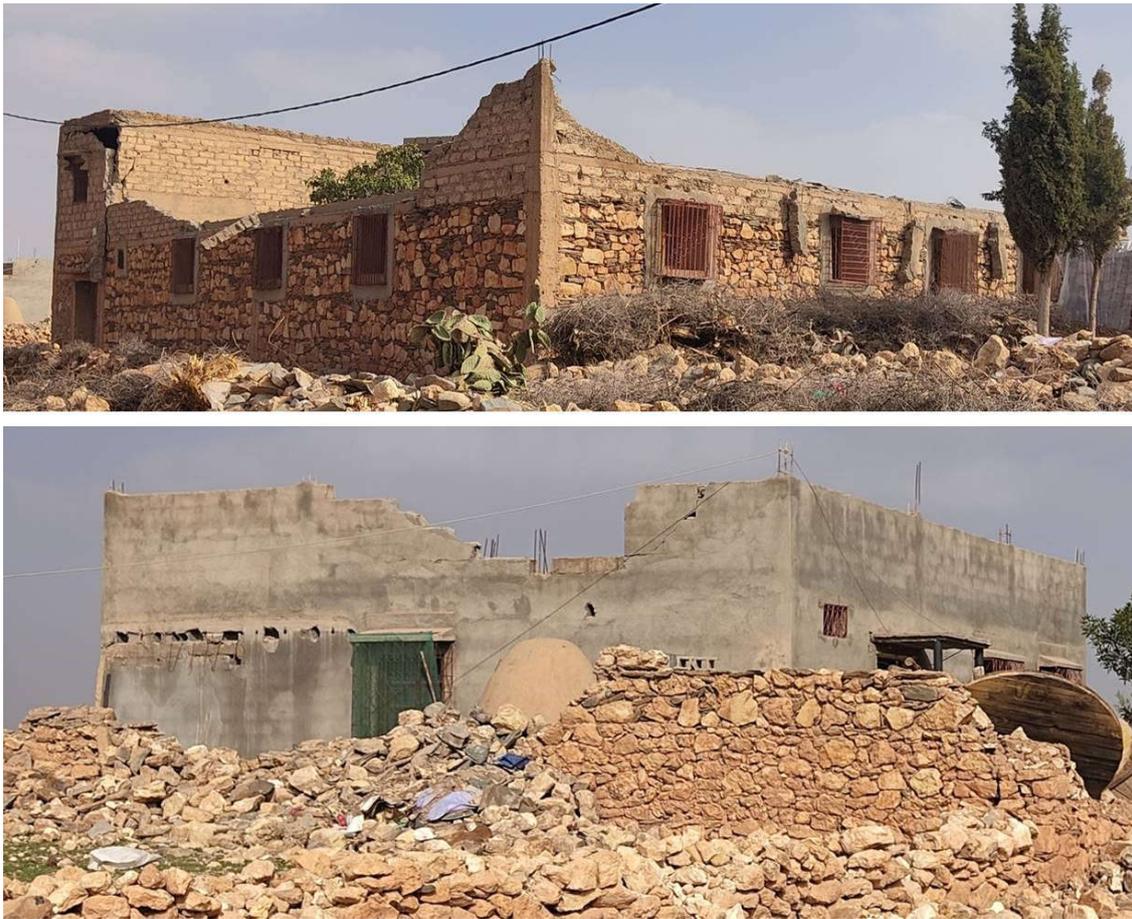
Figure 24. Out-of-plane failure of confined masonry parapet walls in two buildings with different structural wall material (Tafeghaghte) (**both**).

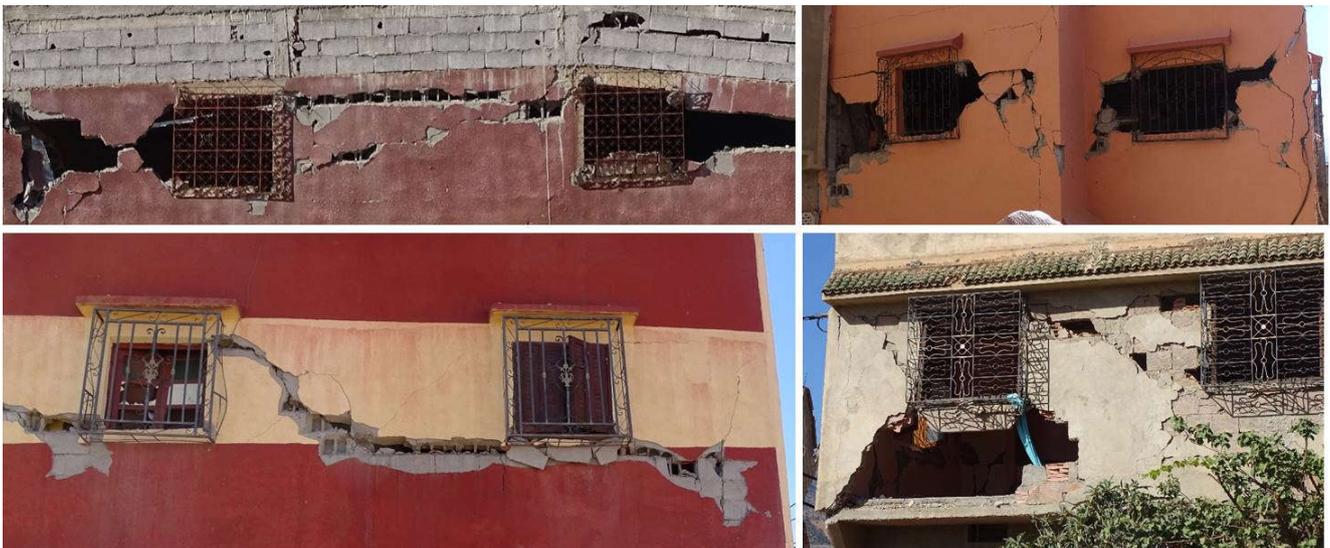
Finally, a key aspect of these structures that should not be ignored is the scarcity of confining elements found. Most buildings presented a lack of RC elements that confined the masonry in the door and window openings (Figure 25). This absence facilitated the openings acting as weak point determinant for the damage in the resistant walls.

Figure 25. Damage mainly due to the absence of reinforced-concrete confining elements in door and window openings (Amizmiz) (**all**).

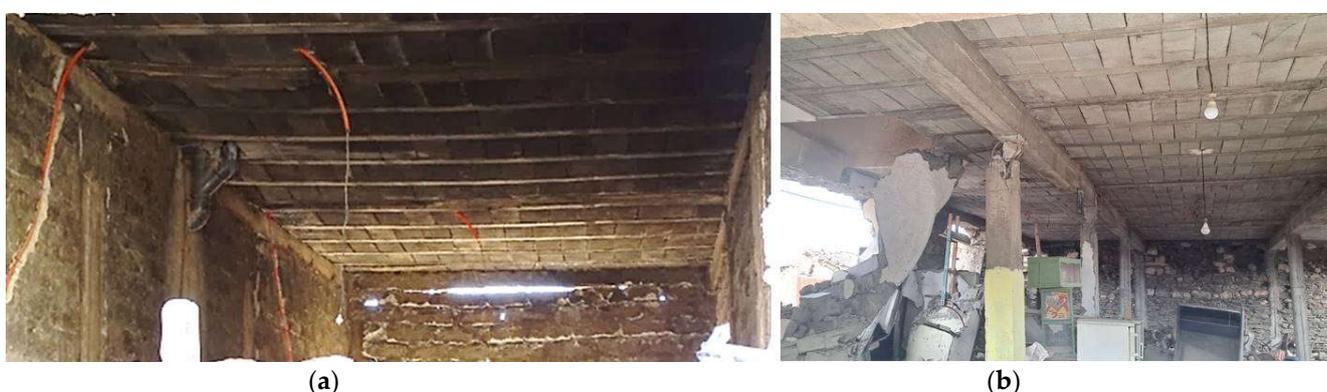
Figure 26. Buildings presenting a structural system which provides seismic resistance and stiffness mainly in only one of the two orthogonal directions. (a) Amizmiz; (b) Tafeghaghte.

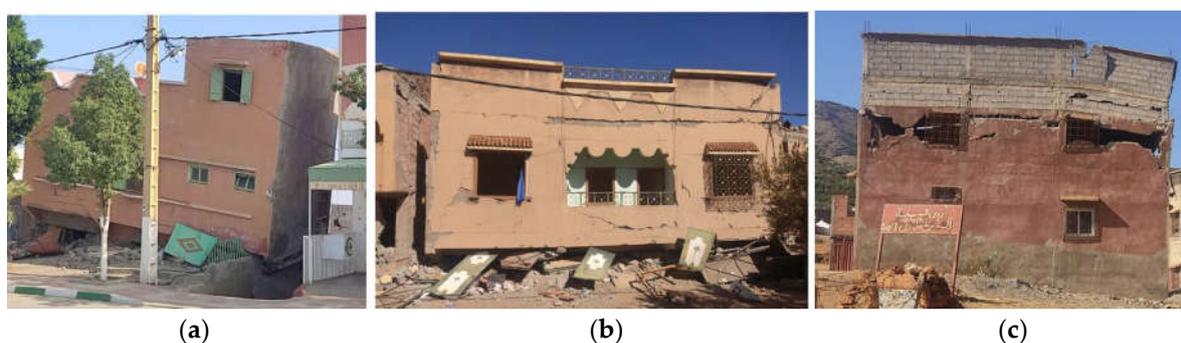
Figure 27. (a) Building in which the minor presence of shear-resistance walls on the ground floor resulted in a weak ground-story overturning failure (Amizmiz). (b) Building in which the excessive

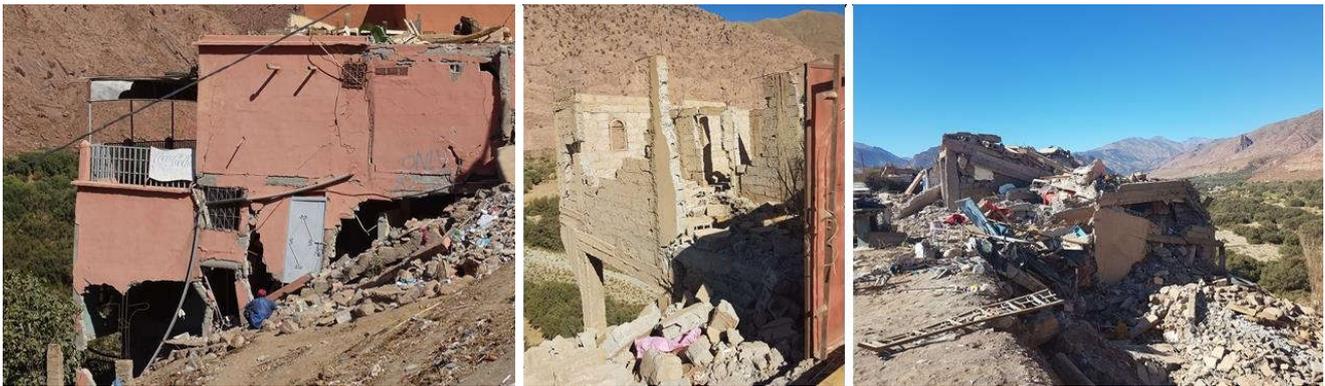
Figure 28. Buildings located on slopes and presenting very different column lengths (Talat N'Yaaqoud).

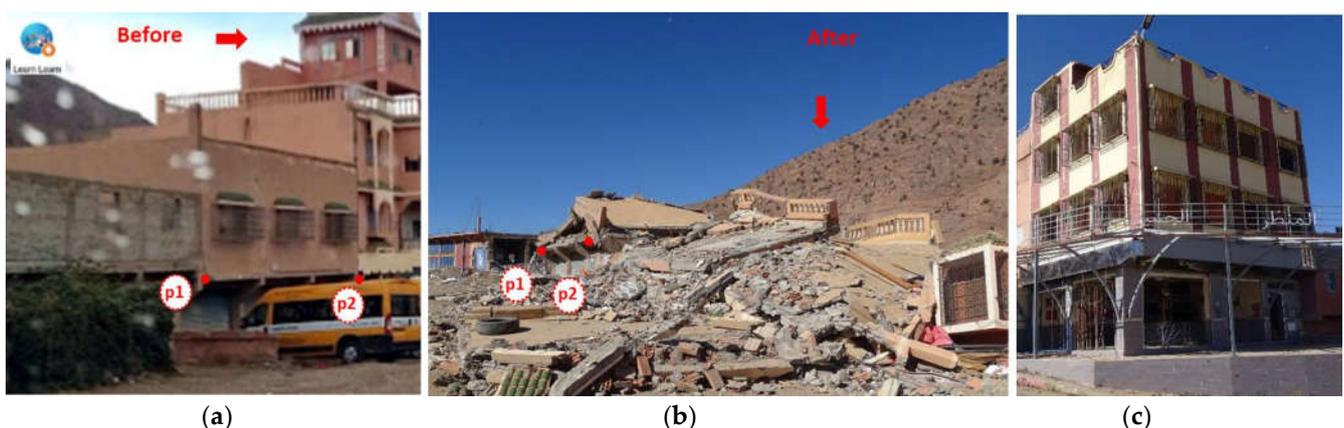
Figure 29. (a) and (b): state of a building before and after the earthquake (red dots). The building exhibited a high number of irregularities in height and plan, such as differences in stiffness and strength and balconies. p1 and p2 are inserted as reference points (Talat N'Yaaqoud). (Source photo before the earthquake: Google Maps, <https://www.google.es/maps/place/Talat+N'Yaaqoub,+Mar-ruecos>, accessed on 18 January 2024). (c) Building with a marked height irregularity between the ground floor and the rest, along with columns displaced from the same vertical line. Possible torsional effects due to the presence of a much more rigid, blank dividing wall and the three very open façades facing the street (Amizmiz).

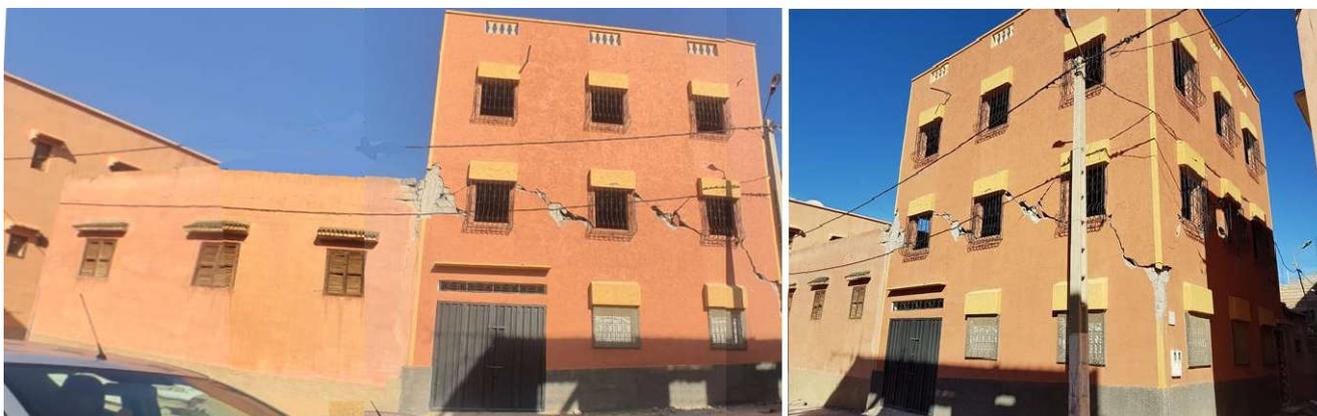
Figure 30. Building on a corner where a lower, more rigid adjacent construction has caused very noticeable pounding effects (Amizmiz).

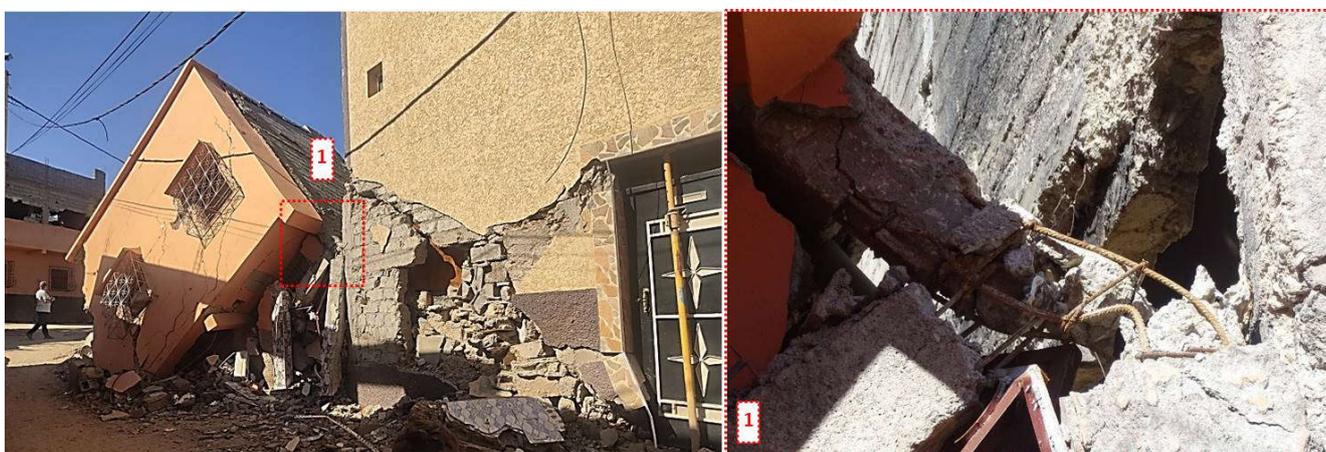
Figure 31. Building located on a corner, collapsed and overturned, presenting a possible weak-story deficiency and pounding effects from the adjacent building. Detail 1. Low resistance of the concrete
